Inspection Report

317 - 225 Belleville St., Victoria, BC, V8V 4T9

**Inspection prepared for: Bob Smith
Date of Inspection: 6/12/2019 Time: 9:00 am
Age of Home: 1976 Size: 1223 sq.ft.
Weather: Clear**

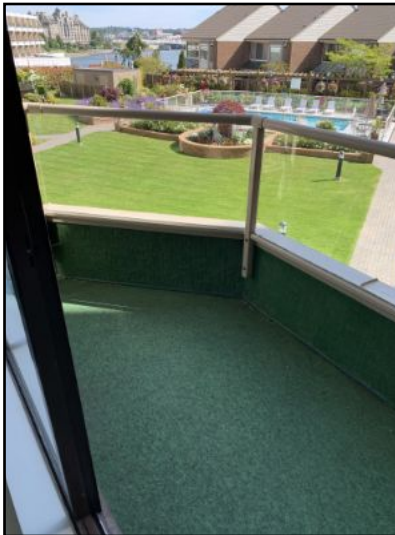
Have carpet removed from decks. (Causes rotting of wood planks.)

- **Have carpet removed from decks. (Causes rotting of wood planks.)**

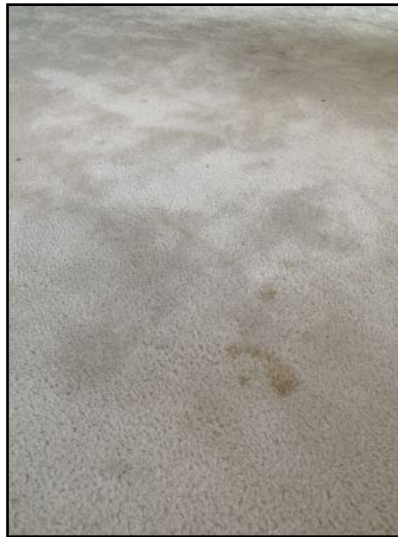
Stained flooring noted

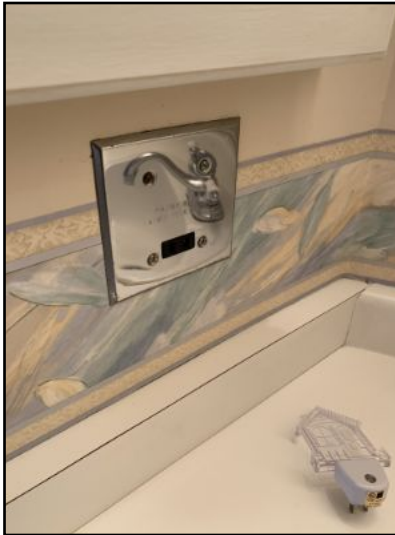
Both Washrooms: Old type razor outlet can overheat and is considered a fire hazard. Have replaced with a GFCI outlet for safety.

• **Both Washrooms: Old type razor outlet can overheat and is considered a fire hazard. Have replaced with a GFCI outlet for safety.**

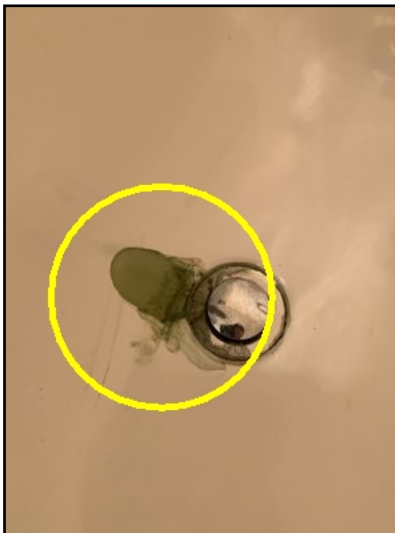
Master Ensuite has damaged tub or tub tile. Replacement may be necessary.

• **Master Ensuite has damaged tub or tub tile. Replacement may be necessary.**

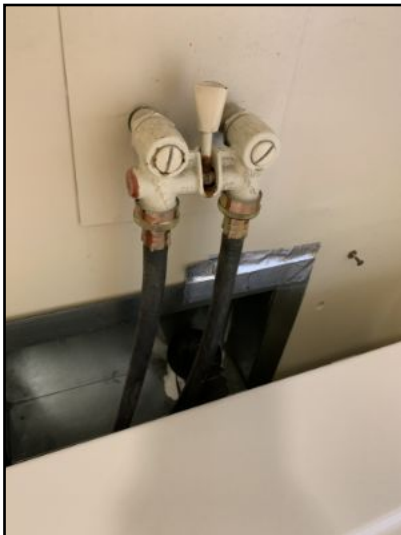
Replace rubber washer hoses with stainless braided lines to prevent hoses from cracking, bursting, leaking and/or possible future water damage

• Replace rubber washer hoses with stainless braided lines to prevent hoses from cracking, bursting, leaking and/or possible future water damage

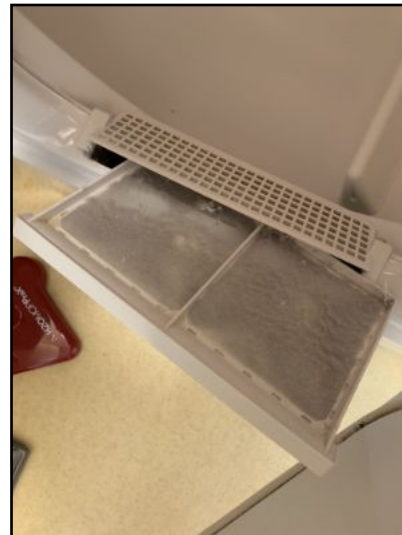
Clean out dryer vent on a yearly basis to prevent possible overheating/fire hazard.

• Clean out dryer vent on a yearly basis to prevent possible overheating/fire hazard.

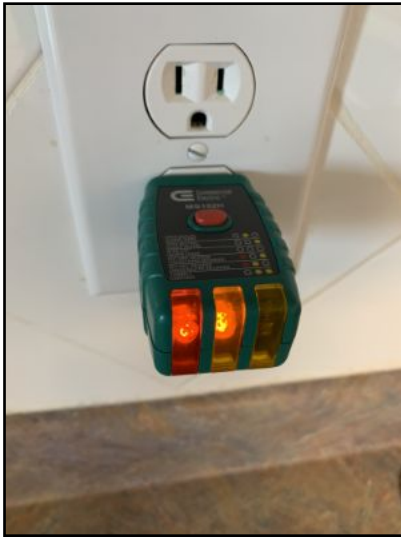
Reverse polarity or non-working outlets noted. Repair for safety

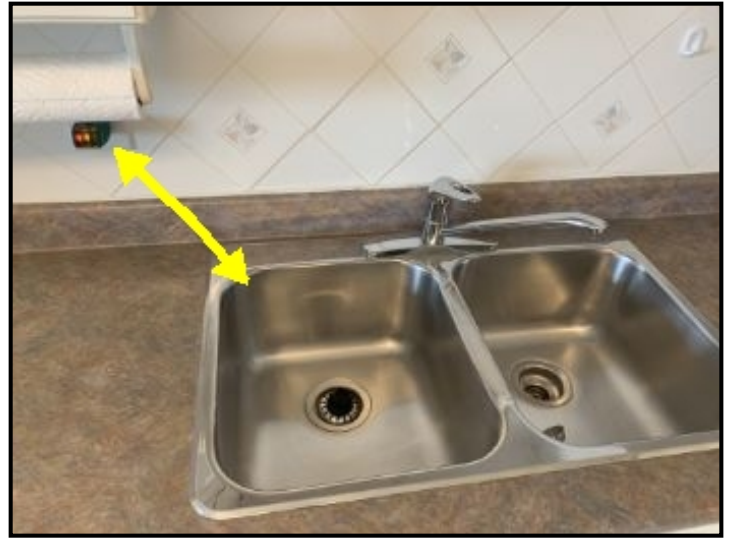
Note: GFCI outlets within 6' of sink are recommended for safety

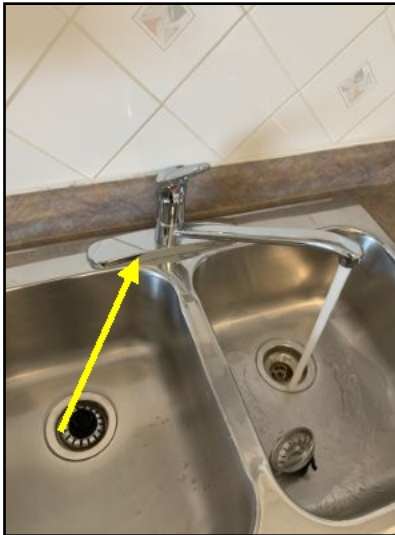
Loose faucet noted, repair required

- **Loose faucet noted, repair required**

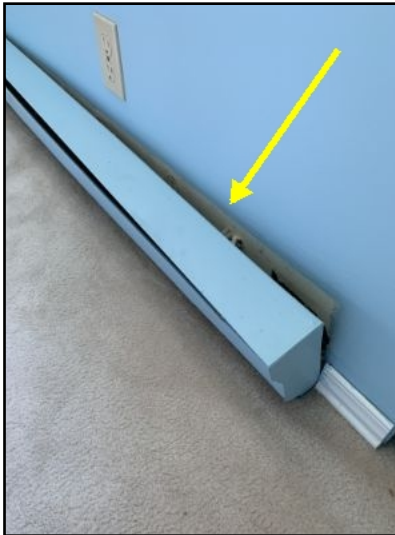
Secure baseboard heater to wall for safety

• **Secure baseboard heater to wall for safety**

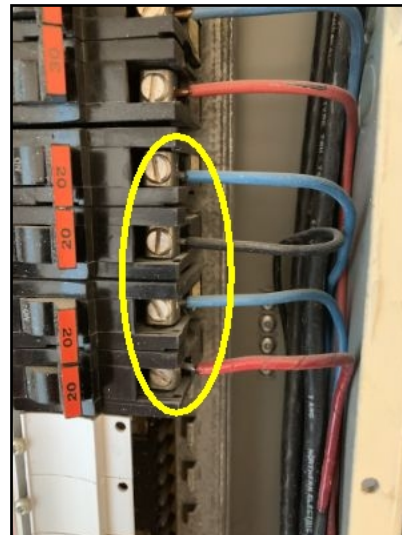
Some branch circuits in panel have aluminum wiring. All outlets, switches, junctions and panel connections should be checked by an electrician for proper fire safety conformance and may be required by your insurance provider.

• **Some branch circuits in panel have aluminum wiring. All outlets, switches, junctions and panel connections should be checked by an electrician for proper fire safety conformance and may be required by your insurance provider.**

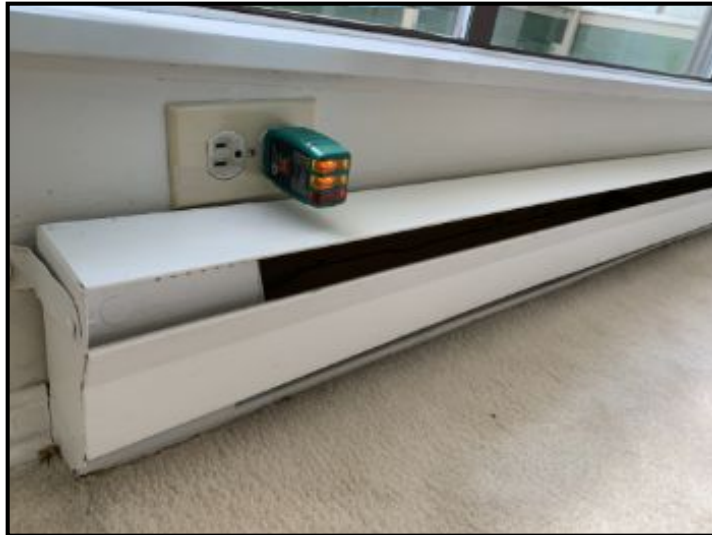
Receptacles placed dangerously close to baseboard heater, keep cords off and away to prevent melting/scorching
