Inspection Report

317 - 225 Belleville St., Victoria, BC, V8V 4T9

**Inspection prepared for: Bob Smith
Date of Inspection: 6/12/2019 Time: 9:00 am
Age of Home: 1976 Size: 1223 sq.ft.
Weather: Clear**

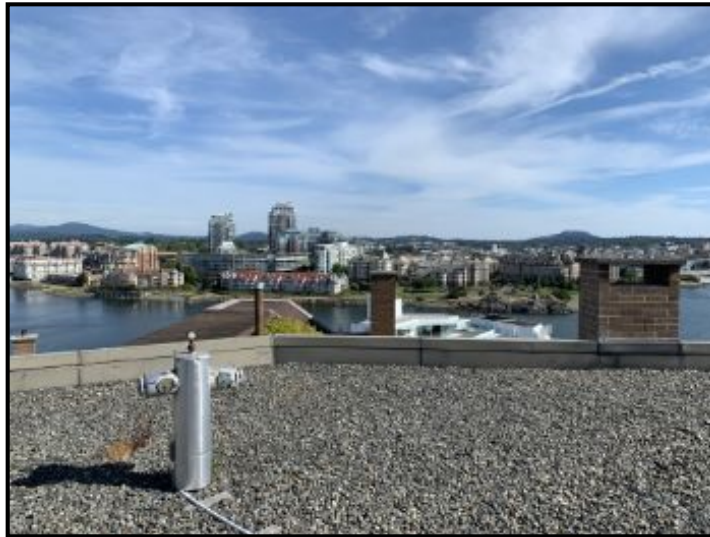
Materials & Observations: - • Tar and Gravel (old) (Typical 15 -25 years life span) • • Low slope (flat) type roof

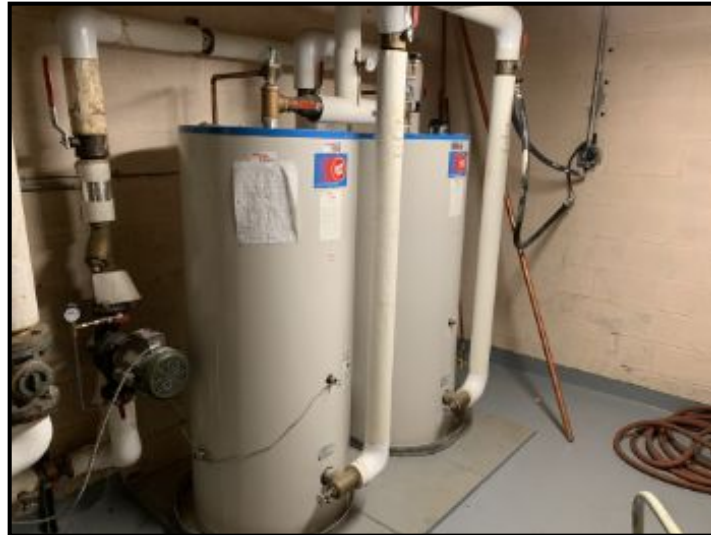
Plumbing Room

Materials & Observations: Appears Functional • Electric • Strata controlled • Tank located in Basement • • PTR valve installed (not tested to avoid leaks) • Vacuum release valve installed

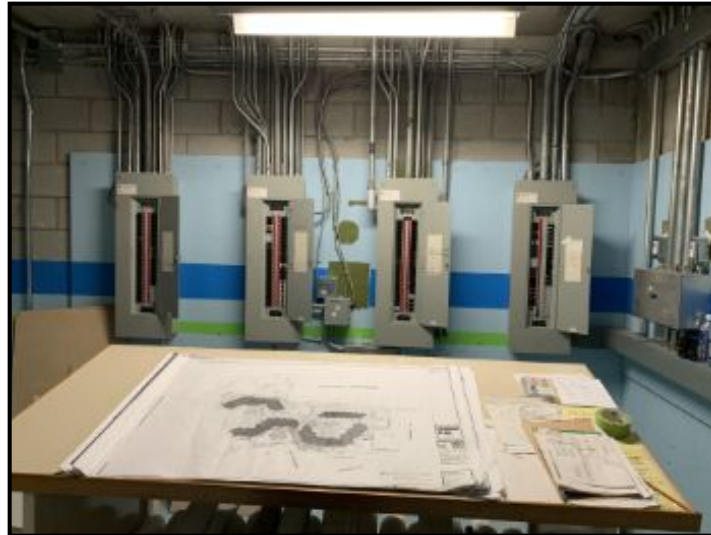
Electrical Room

Materials & Observations: Appears Functional • Underground (Lateral) single phase service

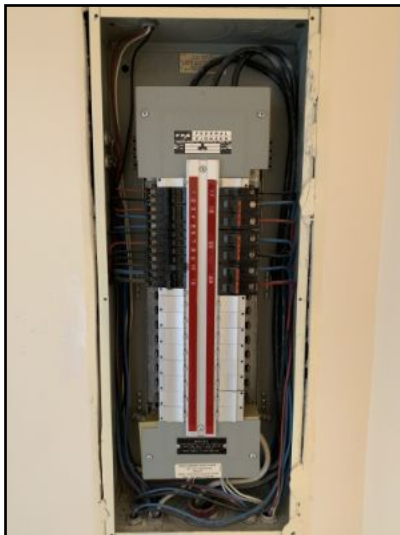
200 A Main Service

• **Some branch circuits in panel have aluminum wiring. All outlets, switches, junctions and panel connections should be checked by an electrician for proper fire safety conformance and may be required by your insurance provider.**
